**Flood Control Project Maintenance  
Levee Inspections**  
**LMA District Cover Sheet**  
**Spring 2019 Levee Inspection Results**

**Reclamation District No. 2031 Elliot**

**Levee Inspection Report By Mile - Spring 2019**

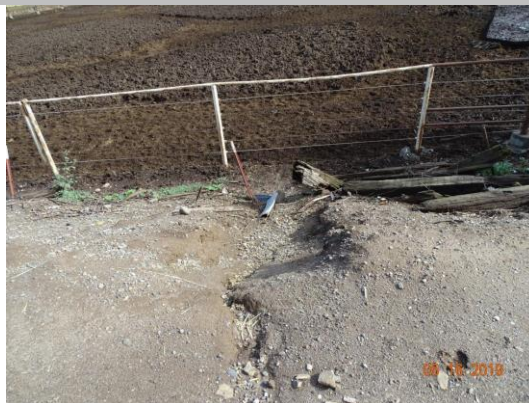
Photo 1 of 1 : SP\_2019\_RD2031\_307\_30\_20190520\_00085.jpg

LM Start	0.02	Rating **	U	Issue No.	30
LM End	0.02	Issue Type +	Ma	Location *	WS
Category	Earthen Levee			GPS Latitude/Longitude	
				Start	End
Item	Erosion / Bank Caving			37.709993 °	37.709993 °
				-121.155771 °	-121.155771 °
DWR ID	DWR_RD2031_01_s _ 2019_30				
Comment Code					
E2 : Schedule repair of erosion site prior to the next inspection.					
Inspector Comment					
Erosion caused by surface runoff starting on waterside shoulder extending down to the waterside slope to the toe. Approxmate size of erosion-4ft wide, 1 ft deep, 8 ft long.

View of waterside erosion caused by surface runoff. Erosion measures approximately 4 ft wide (on slope), 1 ft. deep, 8 ft. long. (Spring 2019)

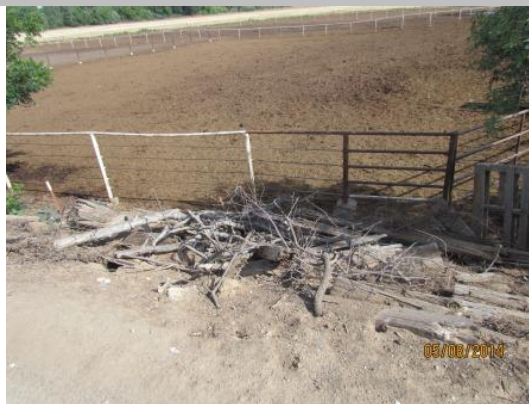
Photo 1 of 1 : SP\_2019\_RD2031\_307\_122\_20190313\_00019.jpg

View of the pile of debris on the waterside levee slope.

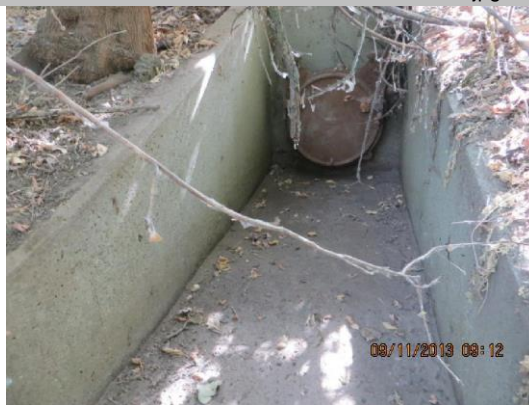
Photo 2 of 2 : UCIP\_SP\_2019\_20024\_33923.jpg

Concrete headwall and flapgate on WS toe.

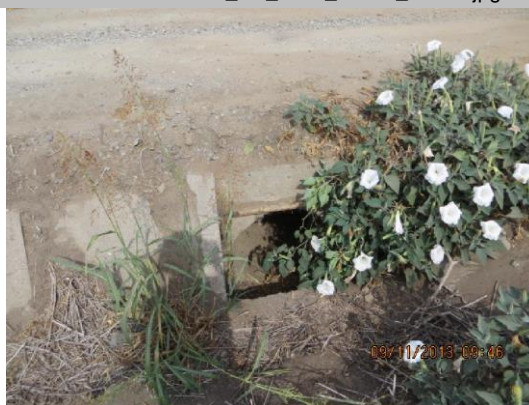
Photo 1 of 3 : UCIP\_SP\_2019\_20046\_33946.jpg

LM Start	0.72	Rating **	M	Issue No.	975	
LM End	0.72	Issue Type +	En	Location *		
Category	Supplemental			GPS Latitude/Longitude		
				Start	End	
Item	DWR UCIP Field Study			37.701912 °	37.701912 °	
				-121.161642 °	-121.161642 °	
DWR ID	20440					
Comment Code						
Inspector Comment						
FS_ID:20046						
DS_ID:20440						
EP_NO: N/A						
Repair Type: Non-Urgent						
Crossing Status: Found						
UCIP Comments: Alfalfa valve on the WS toe is damaged.						
FIELD_STRUCT_DESC: 30-inch corrugated metal irrigation pipe through the levee, 5 feet below the crown. Flashboard slots in concrete headwall on the landside (LS). Distribution box with an alfalfa valve on the waterside (WS). Installed by USACE in 1966. Replaced a 30-inch pipe at the same location. [Additional Reference(s): DWR Levee Log, 2005. USACE San Joaquin O&M Manual 4, June 1968].						
FS Date: 9/11/2013

Concrete headwall and pipe at concrete channel along landside shoulder of levee.

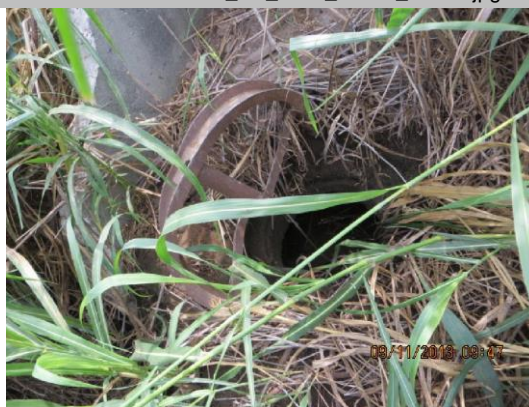
Photo 3 of 3 : UCIP\_SP\_2019\_20046\_33944.jpg

Damaged alfalfa valve.

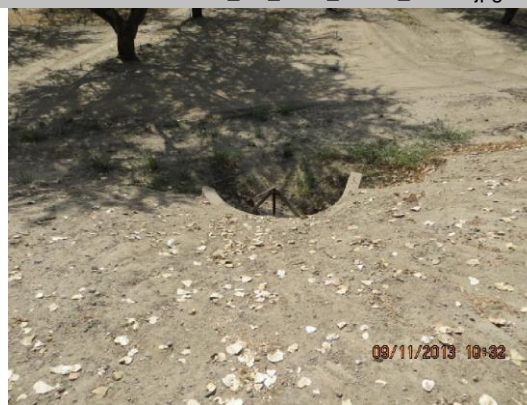
Photo 1 of 3 : UCIP\_SP\_2019\_47158\_74940.jpg

LM Start	0.92	Rating **	M	Issue No.	978
LM End	0.92	Issue Type +	En	Location *	
Category	Supplemental			GPS Latitude/Longitude	
				Start	End
Item	DWR UCIP Field Study			37.699692 °	37.699692 °
				-121.163977 °	-121.163977 °
DWR ID	20444				
Comment Code					
Inspector Comment					
FS_ID:47158 DS_ID:20444 EP_NO: N/A Repair Type: Non-Urgent Crossing Status: Indicator Found UCIP Comments: Need site visit by UCIP--Concrete headwall present on landward side toe. Need to coordinate with owner to determine if this headwall is for 24-inch pipe or if the structure is part of drainage system that could run parallel to levee. FIELD_STRUCT_DESC: 24-inch drainage pipe of an unknown material through the levee, 3.5 feet below the crown. Flap gate on the waterside (WS) end. [Additional Reference(s): DWR Levee Log, 2005]. FS Date: 9/10/2013

Concrete structure located on landward side toe.

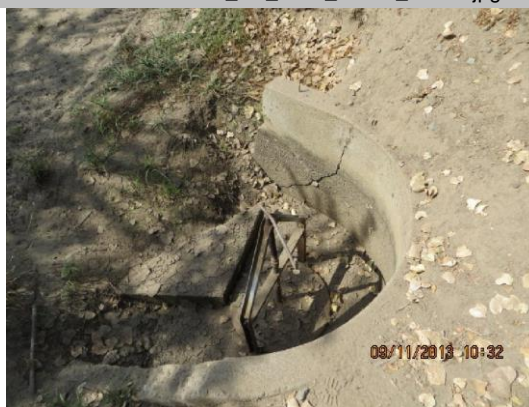
Photo 3 of 3 : UCIP\_SP\_2019\_47158\_74942.jpg

Structure buried with soil--no access.

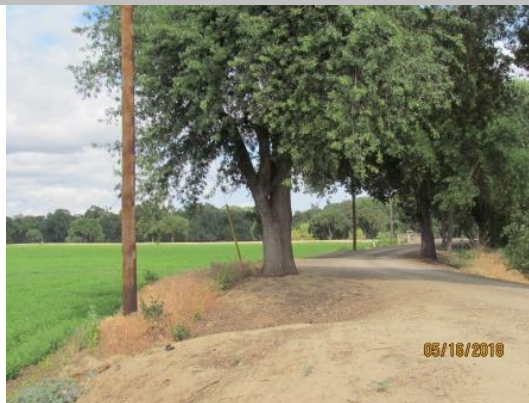
Photo 1 of 1 : SP\_2019\_RD2031\_307\_47\_20190313\_00011.jpg

View looking downstream landside of three power poles on the levee and levee slope.

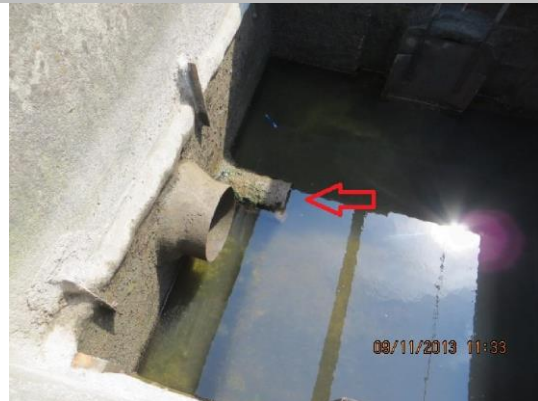
Photo 3 of 3 : UCIP\_SP\_2019\_20085\_34008.jpg

Pipe visible inside concrete distribution box on LS shoulder.

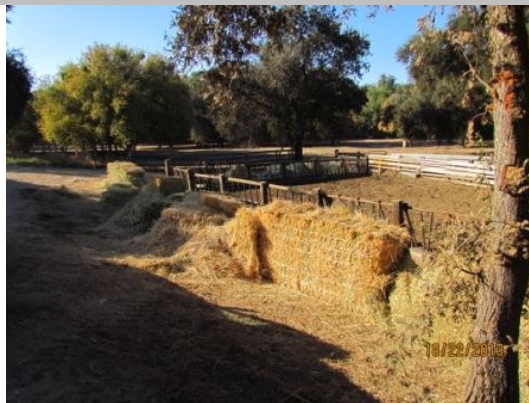
Photo 1 of 1 : SP\_2019\_RD2031\_307\_37\_20190313\_00009.jpg

View of the hay bails at the waterside levee toe.

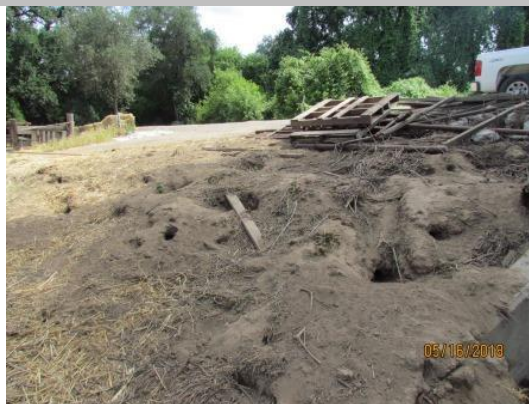
Photo 1 of 1 : SP\_2019\_RD2031\_307\_49\_20190313\_00013.jpg

View of the waterside where several squirrel holes are and active rodent activity.

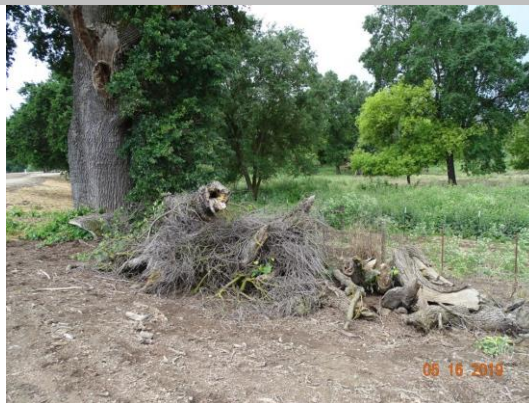
Photo 1 of 1 : SP\_2019\_RD2031\_307\_42\_20190520\_00086.jpg

View of prunings on waterside slope. (Spring 2019)

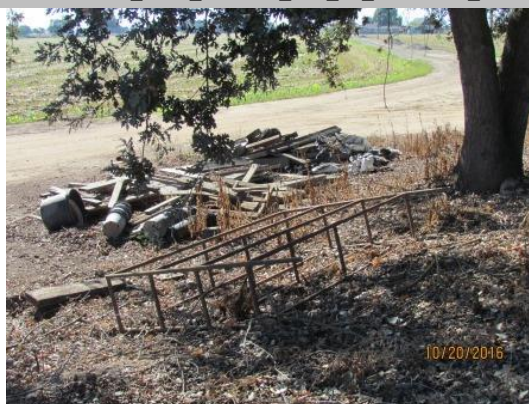
Photo 1 of 2 : SP\_2019\_RD2031\_307\_53\_20190313\_00015.jpg

View of the debris at the landside levee toe.

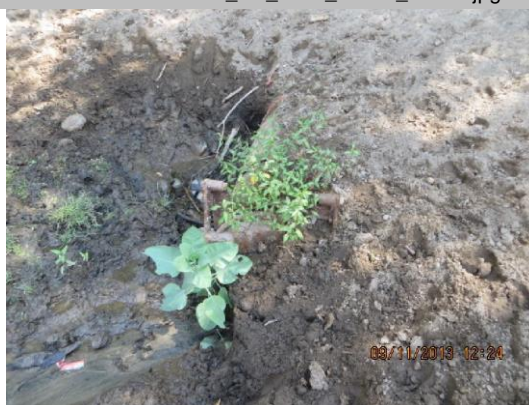
Photo 3 of 3 : UCIP\_SP\_2019\_51340\_39001.jpg

Flapgate partially blocked by soil on WS toe.

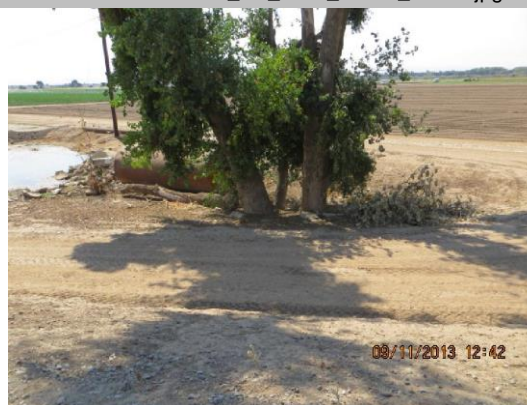
Photo 2 of 3 : UCIP\_SP\_2019\_20449\_34505.jpg

Pipe not visible on LS toe.

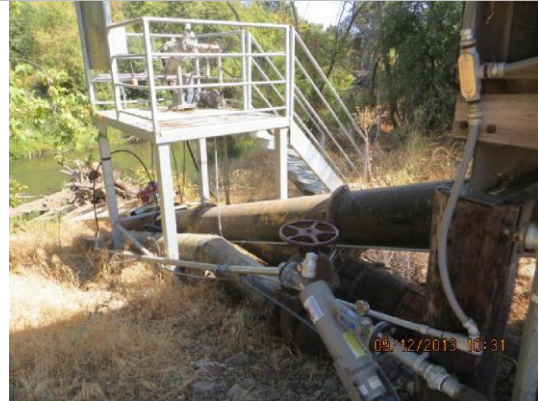
Photo 3 of 3 : UCIP\_SP\_2019\_20667\_34748.jpg

Pipe with debris flow buildup at inlet visible on WS toe.

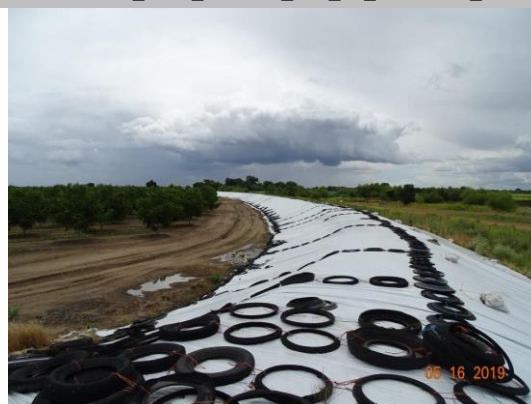
Photo 1 of 2 : SP\_2019\_RD2031\_308\_16\_20190520\_00043.jpg

View of visqueen on crown and landside slope installed in 2017. (Spring 2019)

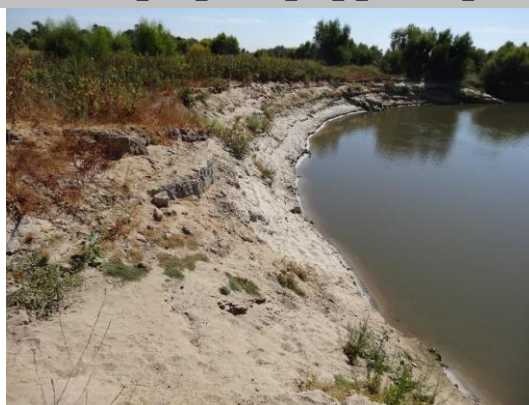
Photo 1 of 4 : SP\_2019\_RD2031\_308\_1\_20190313\_00001.jpg

Looking upstream of the erosion site.
